# Snag List Report

**Property Address: 123 Sample View, Sample City**

**Development Name: Sample View**

**Date of Inspection: 04/09/2025**

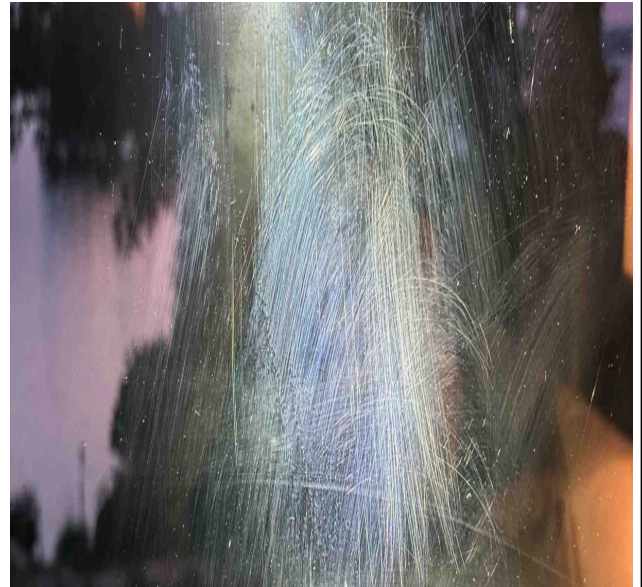
**Snag 17**

17	Living Room	Glazing on RHS window panel is scratched in centre

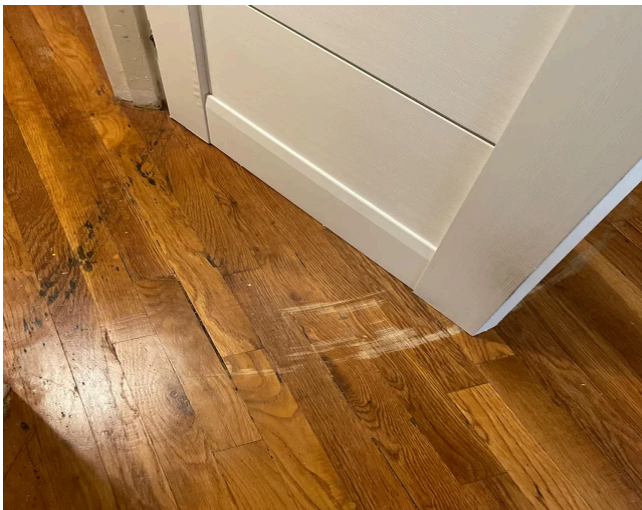
**Snag 18**

18	Living Room	Hallway door is rubbing the floor as it opens	
19	Kitchen	Sink unit door is chipped	
20	Kitchen	Oven cable is missing/not present	
21	Kitchen	Extractor fan is not operational	
22	Stairwell	#4 spindle on stair balustrade is badly chipped	
23	Stairwell	Scuff marks on wall leading upstairs - re-paint	
24	Stairwell	#9 stair tread is cracked/split	
25	Landing	Attic hatch is catching the frame when opening	
26	Landing	Light switch is not operating the light	
27	Front Bedroom	Wardrobe door hinge is not screwed appropriately	
28	Front Bedroom	Hole in ceiling 400mm from window	
29	Rear Bedroom	Window is catching frame when closing	
30	Rear Bedroom	Smoke alarm is not secured tight to ceiling	
31	Bathroom	Sink waste is leaking	
32	Bathroom	Raised tile at doorway - not level with adjacent tiles	
33	Hot Press/Plant Room	Insulate all pipework including elbows & joiners	
34	Hot Press/Plant Room	Seal around all pipes protruding through floor & ceiling
